OT/FAA/NR/92-6
OT-VNTSC-FAA-91-15

**Summary of Findings from the PIREP-Based
Analyses Conducted During the 1988
to 1990 Evaluations of TDWR-Based
and TDWR/LLWAS-Based Alert Services
Provided to Landing/Departing Pilots**

Final Report
July 1992

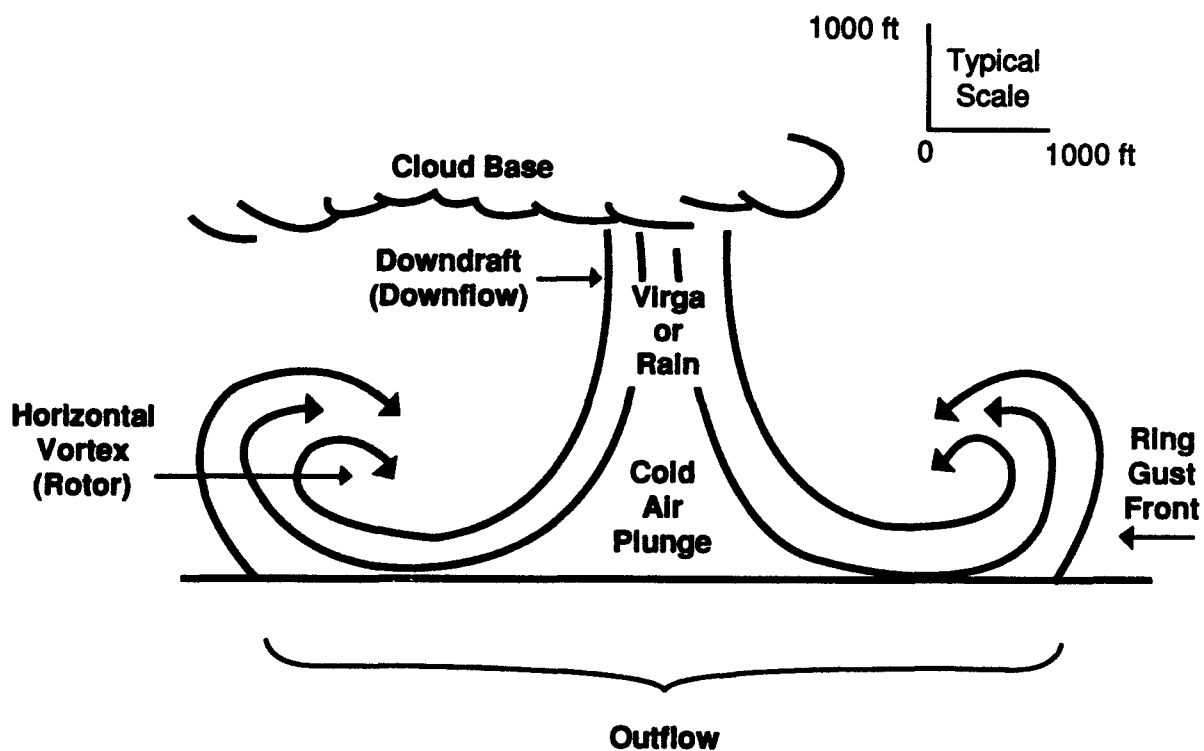
**FIGURE 2-1: BASIC STRUCTURE OF THE MICROBURST
SHOWING COMMONLY ASSOCIATED FEATURES**

Figure 2-1 shows the basic structure of a microburst. On occasion, the outer edge of the outflow would travel some distance from the microburst downflow area and was encountered in its own right, as a separate entity. Landing/departing pilots became involved with microburst-generated gust fronts on several occasions.

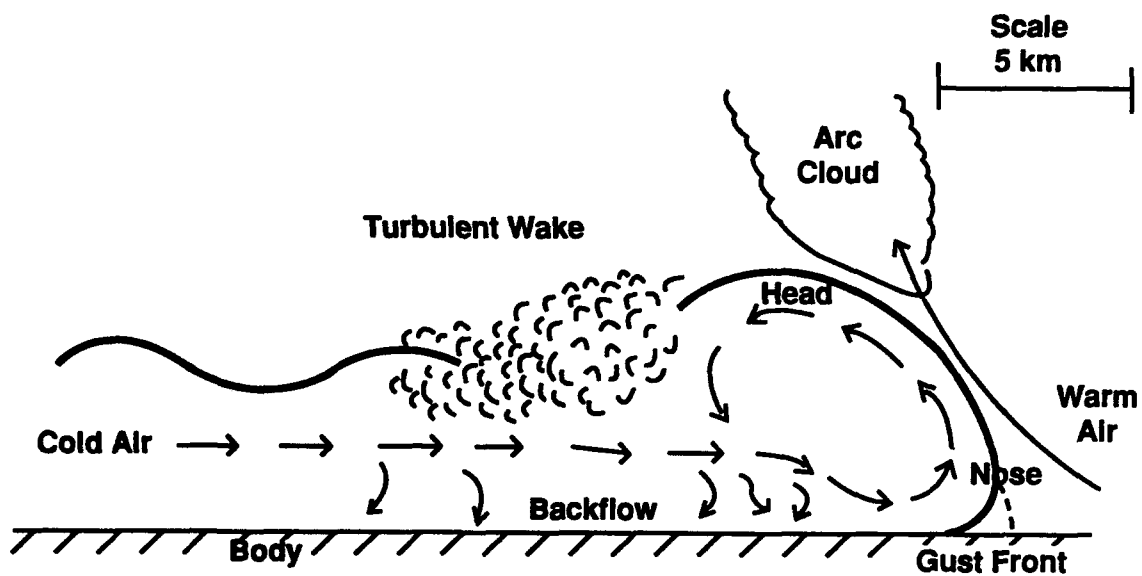
**FIGURE 2-2: BASIC STRUCTURE OF THE GUST FRONT
SHOWING COMMONLY ASSOCIATED FEATURES**

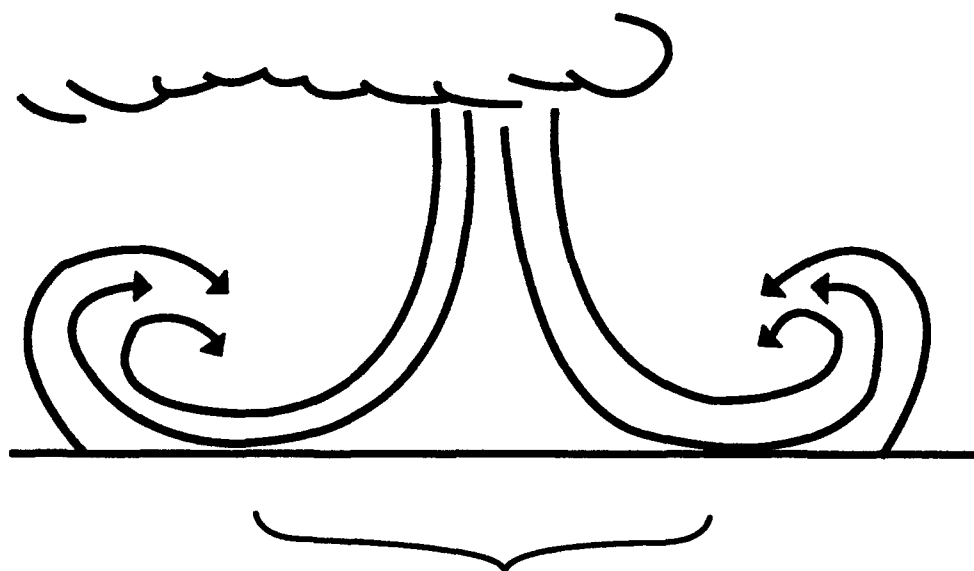
Alert Area Declared by TDWR

(Area of decreasing headwinds that would be experienced by a penetrating aircraft.)

FIGURE 3-1: THE ALERT AREA DECLARED BY TDWR AS COMPARED TO THE OVERALL MICROBURST STRUCTURE

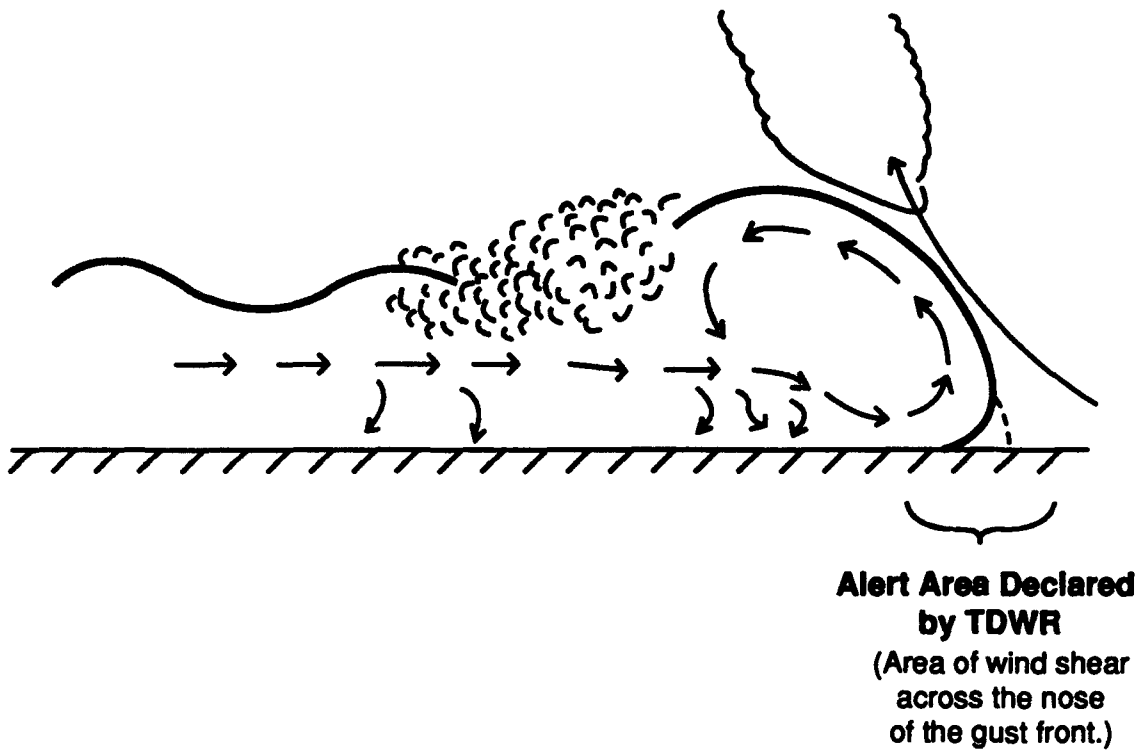
FIGURE 3-2: THE ALERT AREA DECLARED BY TDWR AS COMPARED TO THE OVERALL GUST FRONT STRUCTURE

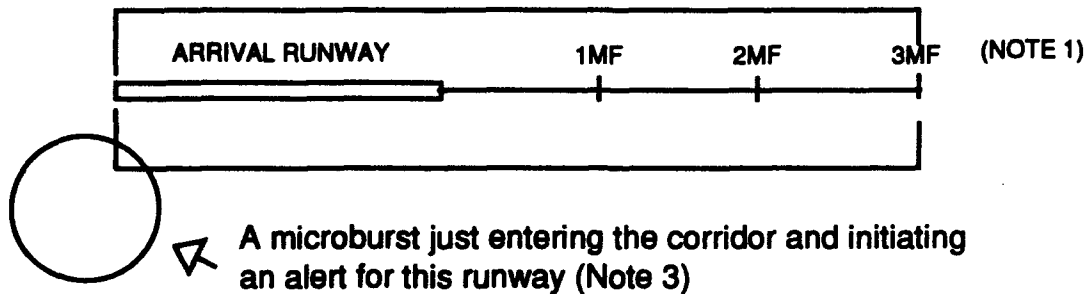
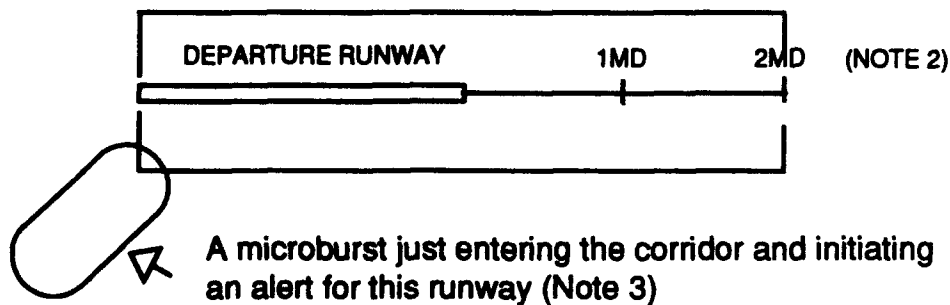
FOR ARRIVAL OPERATIONS

FOR DEPARTURE OPERATIONS

- NOTES:** (1) 3MF stands for "3-Mile Final"
- (2) 2MD stands for "2-Mile Departure"
- (3) The system software depicted microbursts in either of two shapes: The shape of a band-aid if the software sensed that the microburst's outflow had an elongated axis in some direction or the shape of a circle if it did not.

FIGURE 3-3: FINAL FORM OF THE SAFETY CORRIDOR GEOMETRIES USED IN THE EVALUATIONS

Alert coverage was provided to landing pilots for wind shear features inside 3-Mile Final and to departing pilots for wind shear features out to 2-Mile Departure. To increase safety, alert coverage was provided for wind shear features not just on the final approach path and initial takeoff path but for a corridor around these paths (i.e., for 0.5 miles on each side of these paths). Figure 3-3 shows the final form of the safety corridor geometries as of 1990. In the earlier evaluations, the safety corridor for departures extended out to 3-Mile Departure.

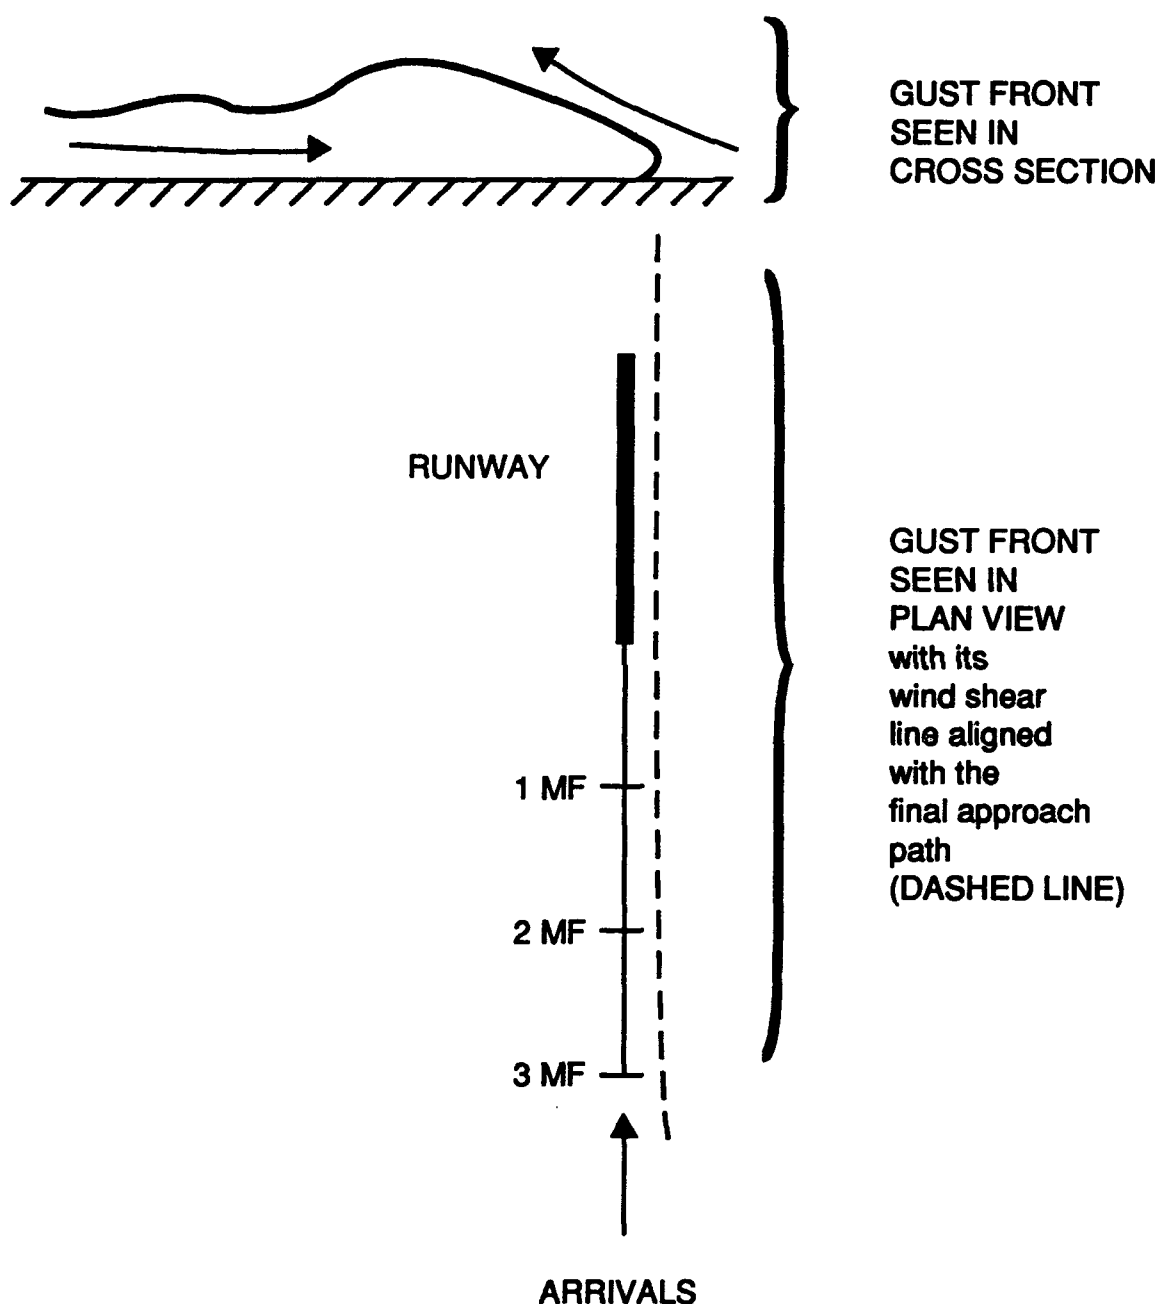
FIGURE 5-1: GUST FRONT ALIGNED WITH THE FINAL APPROACH PATH - A SITUATION NOT PROVIDED ALERT COVERAGE DURING THE EVALUATIONS BY THE TDWR/LLWAS ALERT SYSTEM

The end result of this restriction was that TDWR/LLWAS did not provide alert coverage of gust fronts when the head of a gust front, with its turbulence and downdrafts, became aligned with the final approach path and enveloped it. This situation occurred several times and caused numerous pilots to report significant encounters, including: (1) "pretty rough and miserable ride all the way down," (2) "as tough a landing as I have ever made," (3) "pretty large sinker at 50 feet, quite a large airspeed variation; going around," and (4) "15-knot loss and a marked wind shift at 200 feet... really ought to let people know." This was another area identified for consideration of expanded alert coverage in the Conclusions.
